# Analysis of ceiling tiles and raw materials for Strontium and Sulfur via handheld XRF– a case study for ASTM WK28941

**Marsha S. Bischel, Ph.D.**  
**2 May 2011**

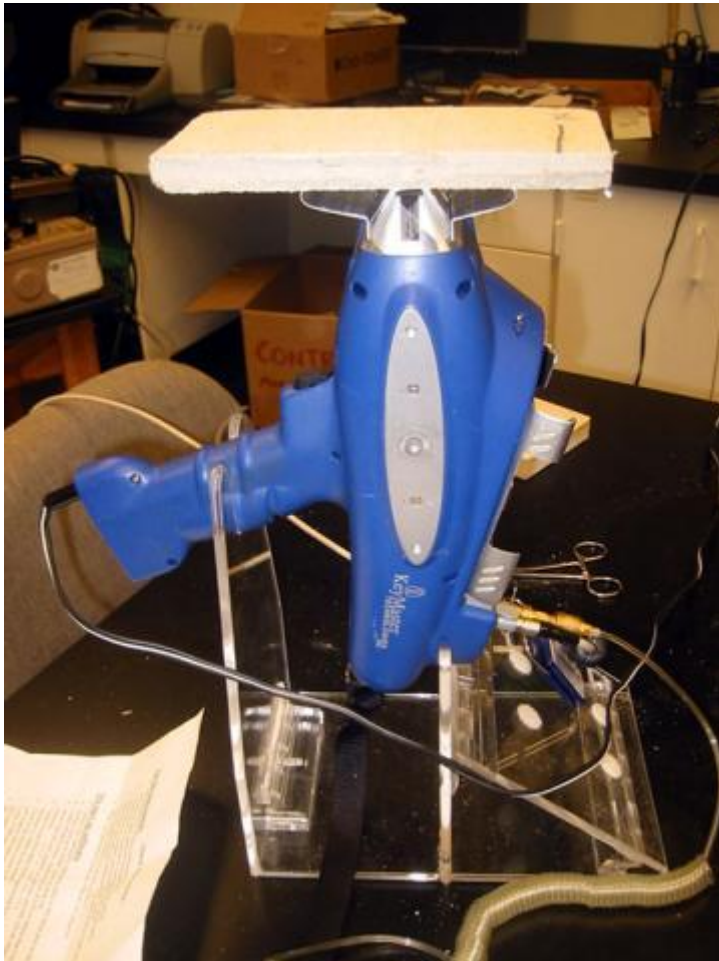
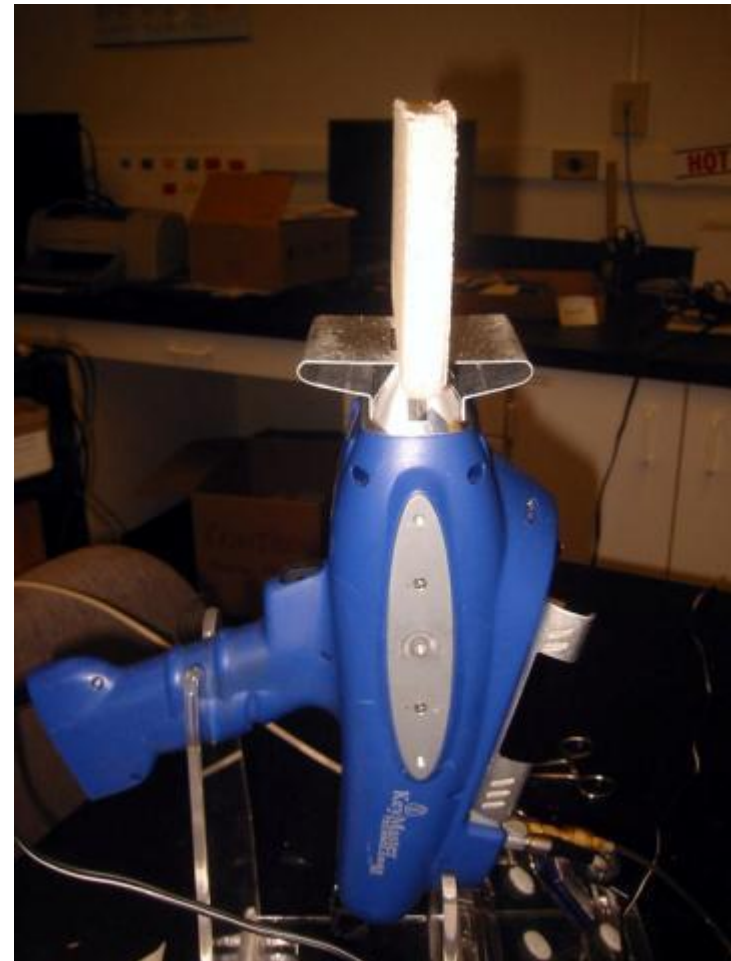
XRF unit and ceiling tiles (with vacuum system in place for low atomic # detection)

- Performed at the Scientific Research and Analysis Laboratory at the Winterthur Museum and Country Estate (DE).
- Handheld KeyMaster TRACer III-V XRF spectrometer
  - Rhenium tube (broad detection capability)
  - Can easily detect elements with atomic number of greater than 19; Strontium has an atomic number of 38.
  - To detect elements with low atomic numbers, including Sulfur at 16, the detection system can be modified.
- Each ceiling board sample was analyzed in three planes: the painted back, painted face and unpainted edge.
  - For the CPSC study, sampling was done through any surface decoration.
- Raw materials were analyzed only once.
