## CASE REPORT

# Neck Injuries Caused by Automatic Two-point Seat Belts: An Analysis of Four Cases

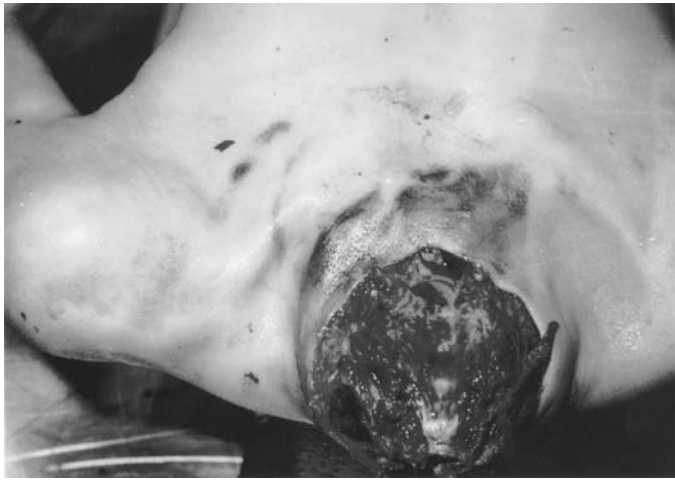
FIG. 1—Decapitation site with adjacent abrasion.

Injuries to the decedent included decapitation at the level of the third cervical intervertebral disc. The line of decapitation was oblique with an upward angle of approximately 45°. The strap muscles, trachea, esophagus, right and left common carotid arteries and the jugular veins were transected with clean edges as if incised. The neck skin immediately inferior to the decapitation site had a patterned injury consisting of a sharply demarcated abrasion and traumatic overstretching injuries indicating that the skin was stretched before the strap lacerated the skin (Fig. 1). Within the abrasion was a 1-cm area of non-abraded, intact skin that resulted from overlapping of the skin as it was pulled and stretched by the strap. Small coarse black fibers matching the material of the seat belt were recovered from the soft tissues at the decapitation site. The right arm and axilla had abrasions consistent with being caused by the shoulder restraint as it rubbed under the decedent's arm before being ejected from the car. The chest and abdominal organs were without injuries.
