# **From Science to Engineering Practice - Evolving a Structural Integrity Framework**

**ASTM 2016 Fatigue Lecture**

**Jerzy Komorowski**

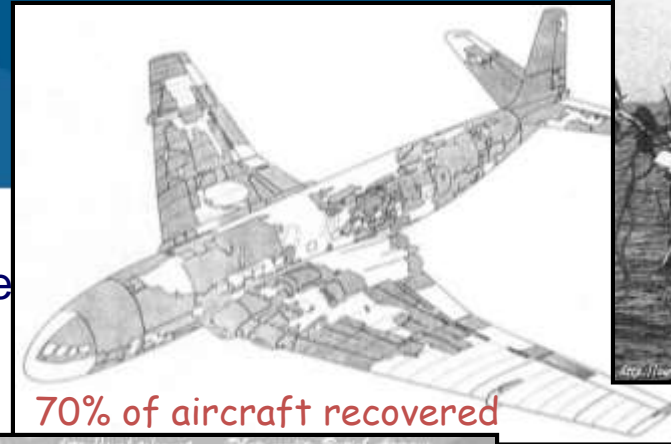
- Between May 1953 and April 1954, three *Comet aircraft* disintegrated in flight, after which all Comet 1 aircraft were withdrawn from service.
- Afterwards a full-scale test was carried out in which the fuselage was submerged in water to simulate the pressurization cycles.
- From the resulting cracks, the relevant fuselage piece of a failed aircraft was recovered from the ocean floor, which showed the "unmistakable fingerprint of fatigue".
- Fatigue cracks due to the stress concentration at nearly-square rear window cutouts caused failures.

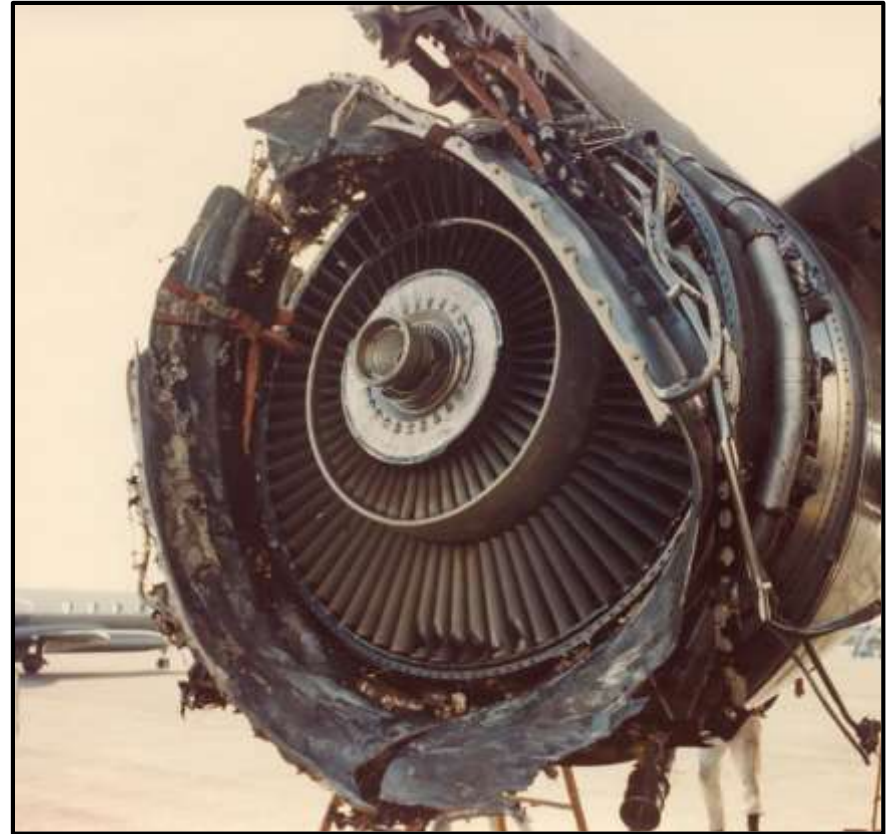
RB211, L1011-TWA 28

- RB211 SITUATION ON THE LOCKHEED TRISTAR (1972, 1973)
  - Two in-flight first stage fan discs burst. One in Dec., 1972 (six days before EA 901), second Jan. 12, 1973-TWA 28
  - No fatalities, but all IMI 685 fan and compressor discs replaced by RR and Lockheed.

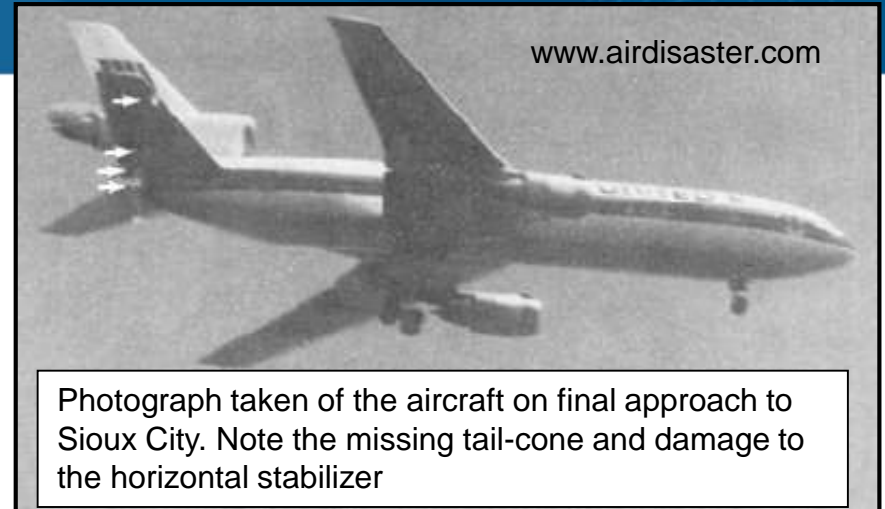
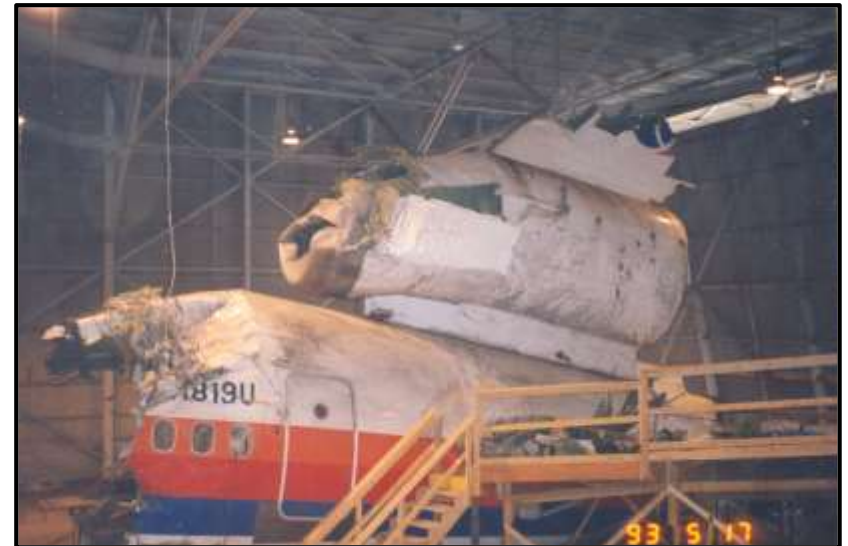
- UA 232-DC10 ACCIDENT  
SIOUX CITY, IOWA (1989)
  - In flight compressor fan disc failure of CF6-6 engine. 113 fatalities. 171 survived.
  - Previous spool failures had occurred (different Ti alloy but same basic problem).
  - Sister discs were cracked.

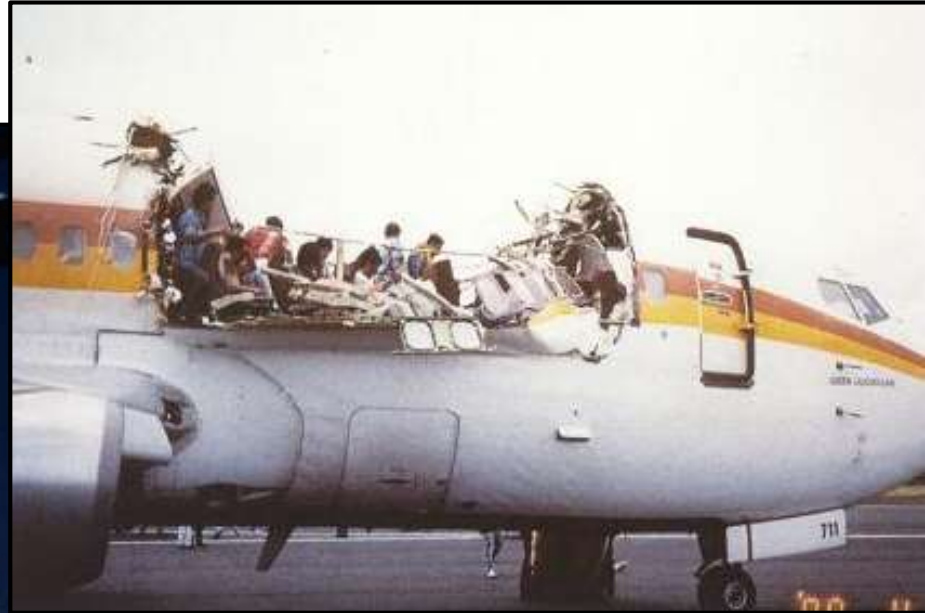
- ALOHA AIRLINES 243 ACCIDENT (1988)
  - The aircraft lost 1/3 of its crown due to a stress fracture while cruising at 24,000 feet. 1 fatality.

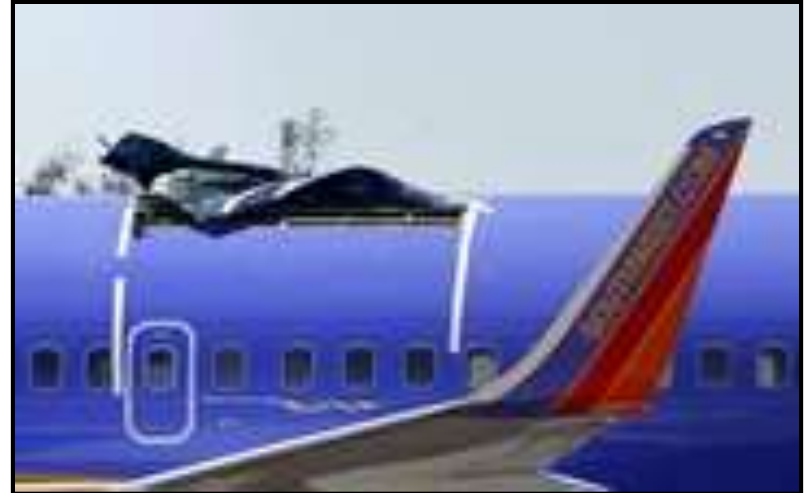
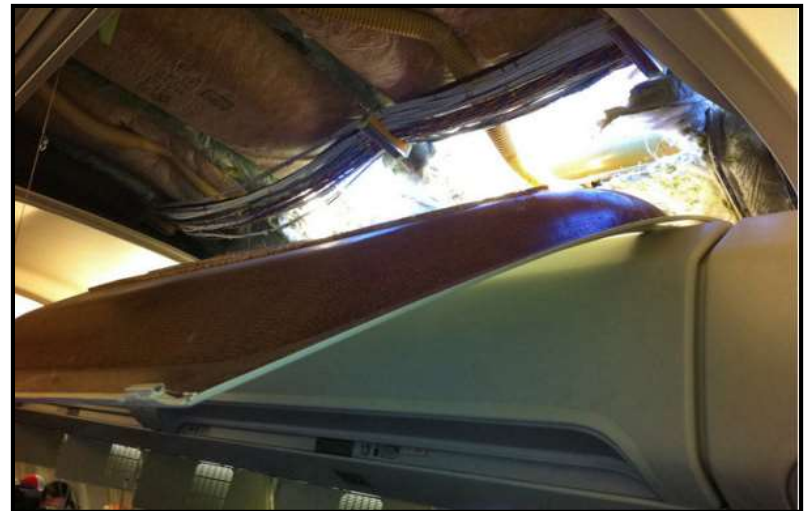
- CAUSE OF SOUTHWEST B733 NEAR YUMA (2011)
  - MISALIGNED rivet holes where two parts of the fuselage were assembled.
  - Wear-induced cracks
  - Riveted joints that failed were not extensively checked because they were thought not to be susceptible to fatigue.

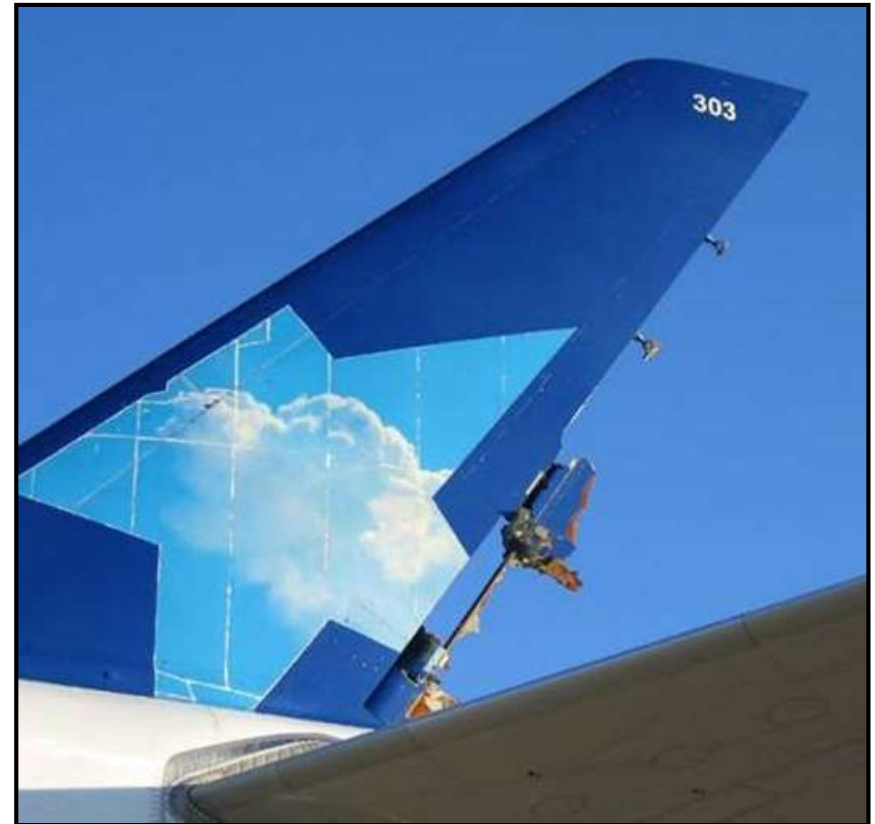
- AIR TRANSAT AIRBUS A310  
C-GPAT
  - On 6th of March, 2005, over international waters a rudder detached from the vertical stabilizer.
  - Rudder is an all-composite structure consisting of two sandwich panels, hinge side spar, top and bottom ribs.
  - “No-Growth” design

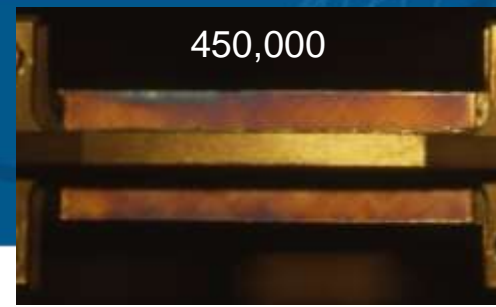
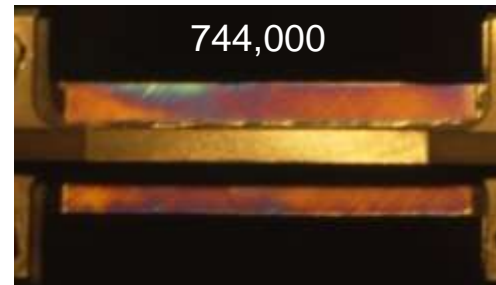
# Composites - fatigue

- No-life **AGAIN!!!!?**
- Service experience
  - Low strain levels ( $<4,000\mu\epsilon$ )
  - Older materials
  - Conclusion – fatigue resistant materials
- Lab experience
  - Small coupons
  - Specimen geometry – edge problem
  - Long period without evident damage – low number of cycles to failure when damage can be observed
- Large transport composite wing weight saving requires higher strains closer to  $6,000\mu\epsilon$ ?

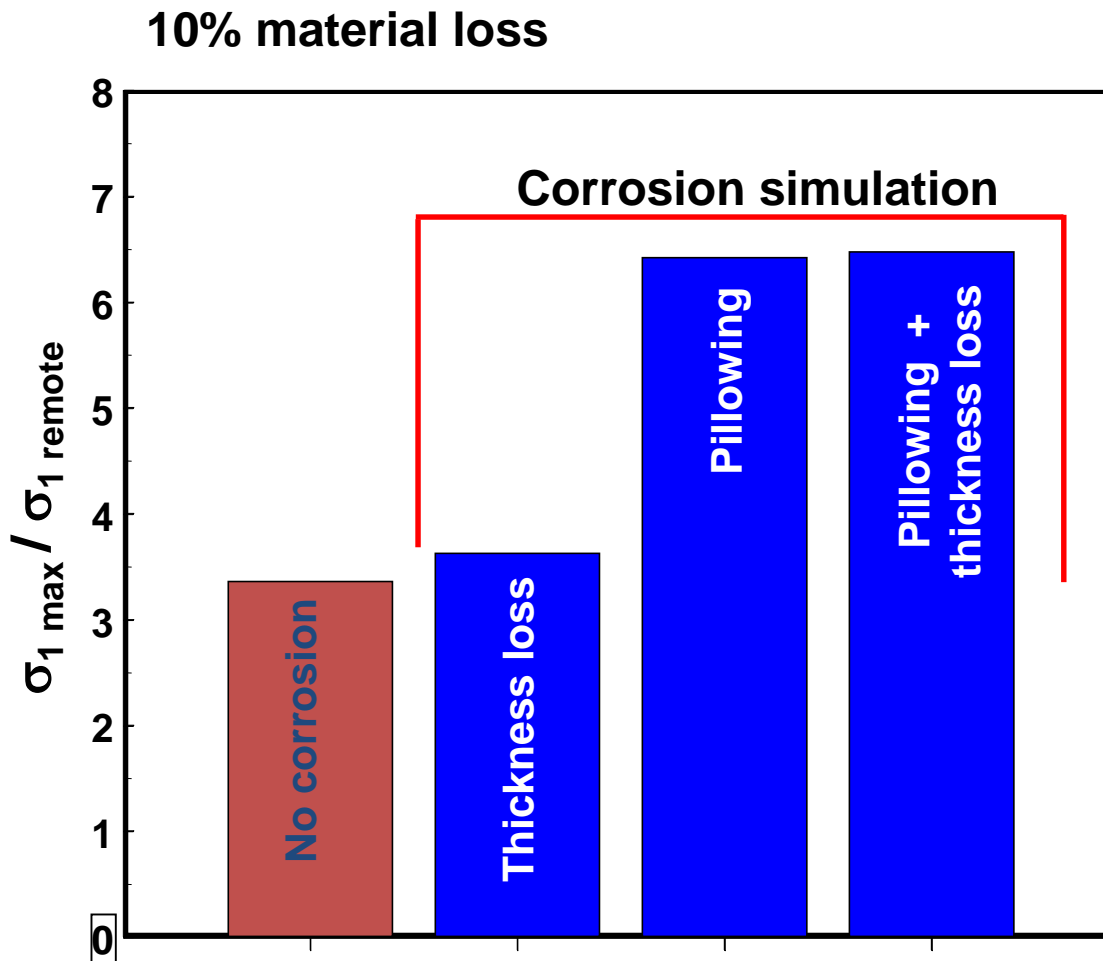
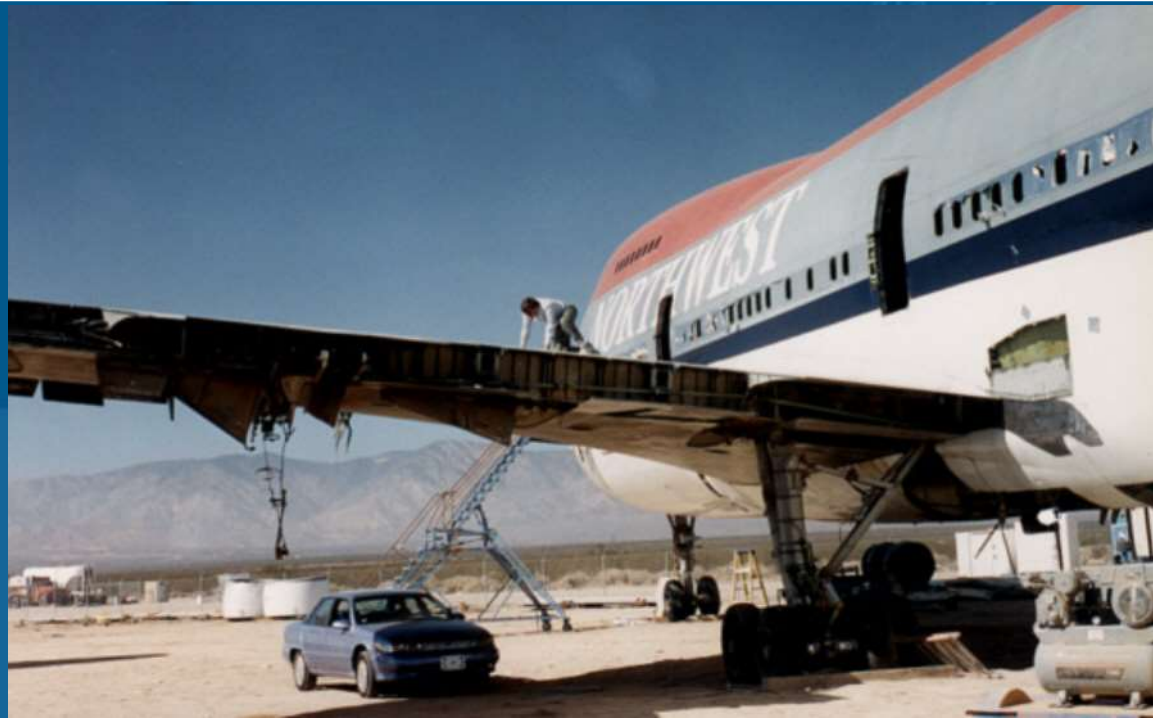
- Finite element models generated with and without thickness loss.
- Results show strains significantly increase due to pillowing as compared to thickness loss effect.

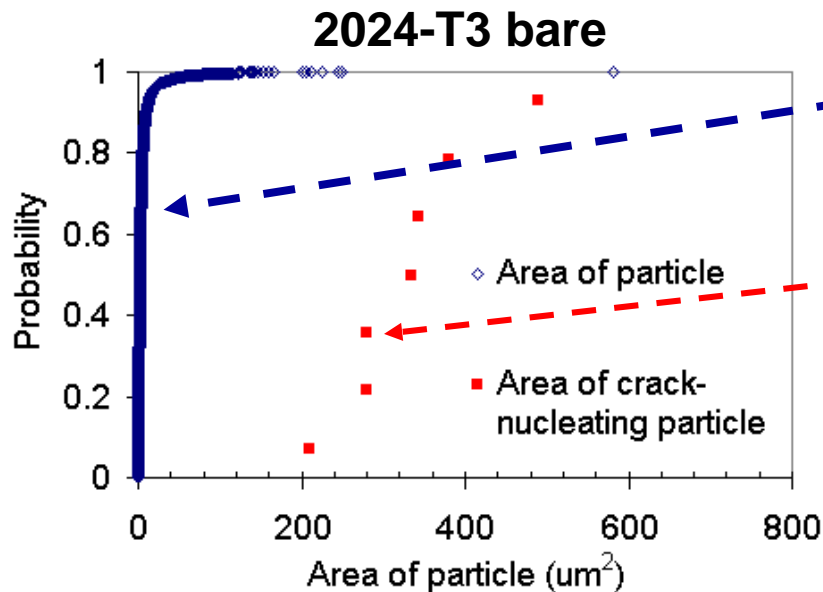
**Initial Discontinuity States (IDS):** Initial population of discontinuities that are in a structure made of a given material as it was manufactured in a given geometric form

**IDS examples:** particles, pores, machining marks/scratches

IDS fatigue subset measured from fracture surfaces **ARC-CMRC**

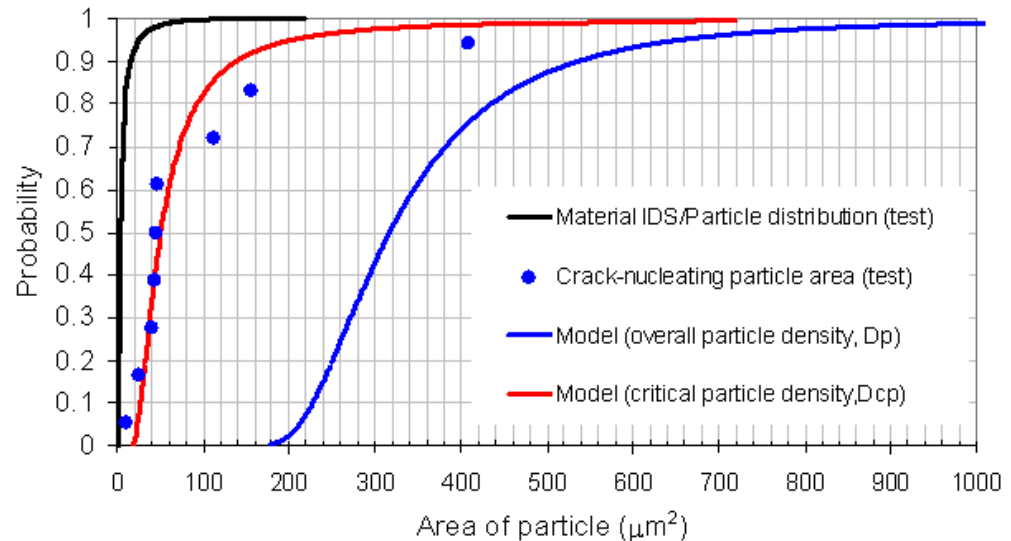
**Extreme value model:** IDS fatigue subset is in the right tail of the overall IDS distribution, which can be determined using the extreme value theory in the highest (95%) stress region, ex. Lognormal (overall IDS) → Frechet (IDS subset).

**Model and test results for crack-nucleating particle (area) for 7050**

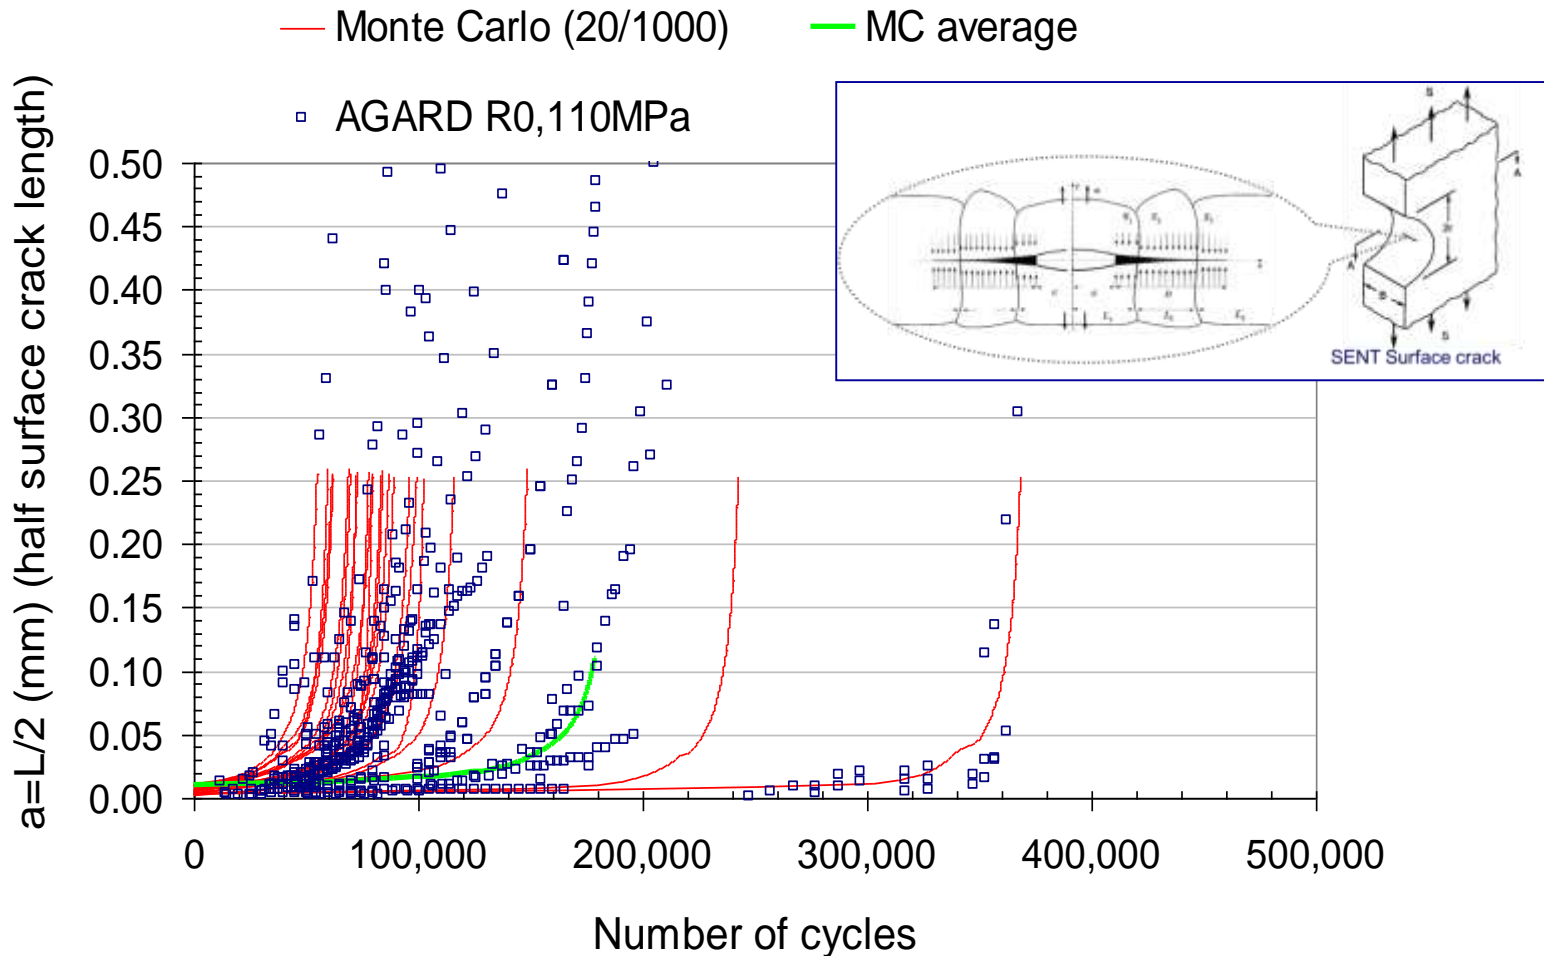
**$a - N$  results for 2024-T351(SENT)**

**Analysis ( $a_0$ : IDS/particle) vs. Test (AGARD 1982)**

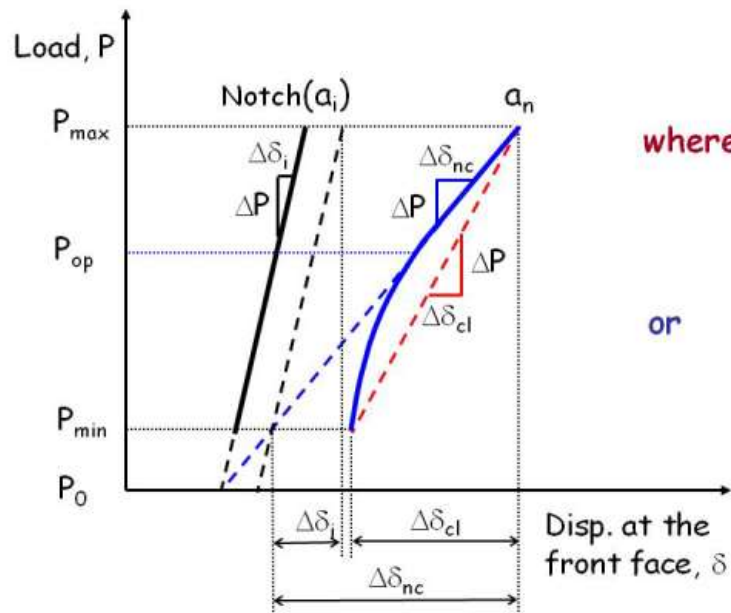
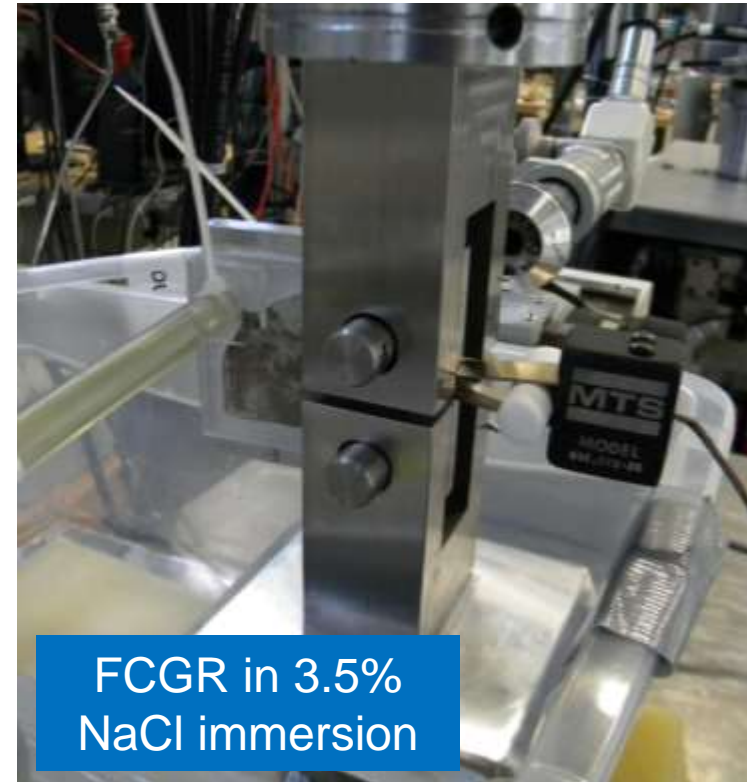
- The adjusted compliance ratio (ACR), developed by K. Donald, is an experimental method for estimating  $\Delta K_{\text{eff}}$ .
- The ACR method intends to measure the crack closure effect below the 2% crack-opening load, and **quantify the remote closure effect induced by residual stress (from forging or welding)**

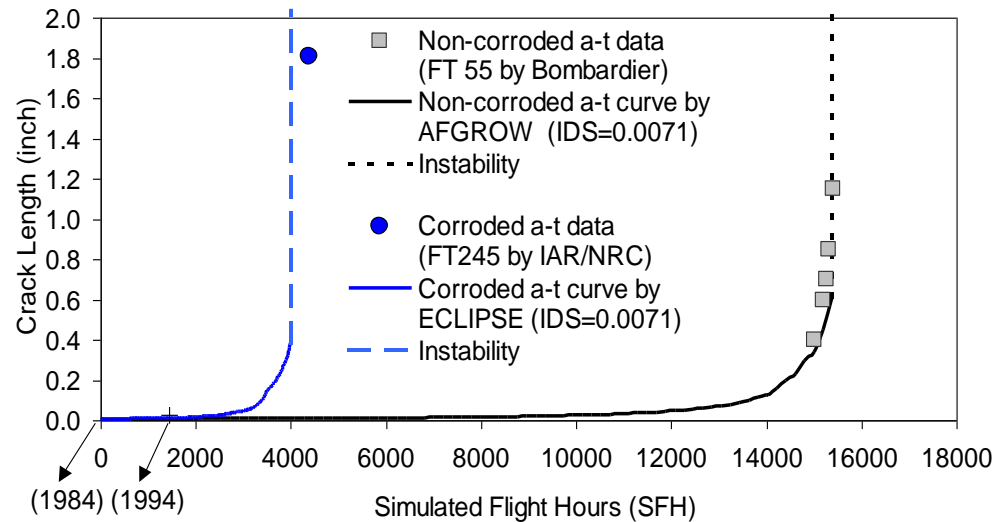
DDT analyses do not generally include possibility of change of criticality of structure – from durability to DT driven.

**Corrosion can have such impact.**

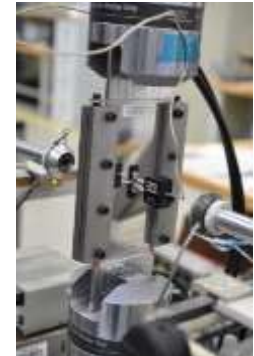
M(T) Test Trials (under DRDC Project)

**Objectives:** Obtain additional Al7249-T76511 material property data to support RCAF for decision-making on ASIP and reduction on maintenance cost by refining the material models of the CP-140. Required data includes:

- Fracture toughness for thin extrusions ( $K_{IC}$ )
- Fatigue crack growth rate (FCGR) properties for negative and high stress ratios ( $R$ ).

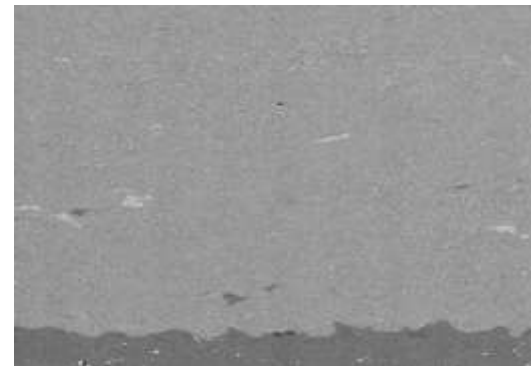
Sprayed density looks promising for 7075  
Property testing to commence early Feb

The objective of this project is to develop an additive material (Cold Spray) repair capability for the Canadian Forces. The research focus is the restoration of parts reworked (blended) beyond current repair limits.
